# Hydroelectric generators: The forgotten mechanical component

R. Dreher, B. Sanosian, D. Erpenbeck and W. Akaishi, Stantec Power & Dams, USA

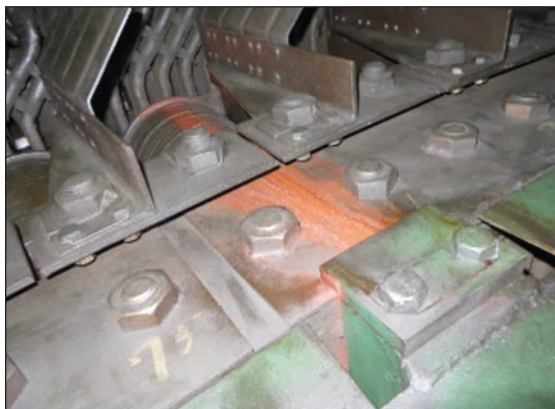
(a) Signs of excessive movement.

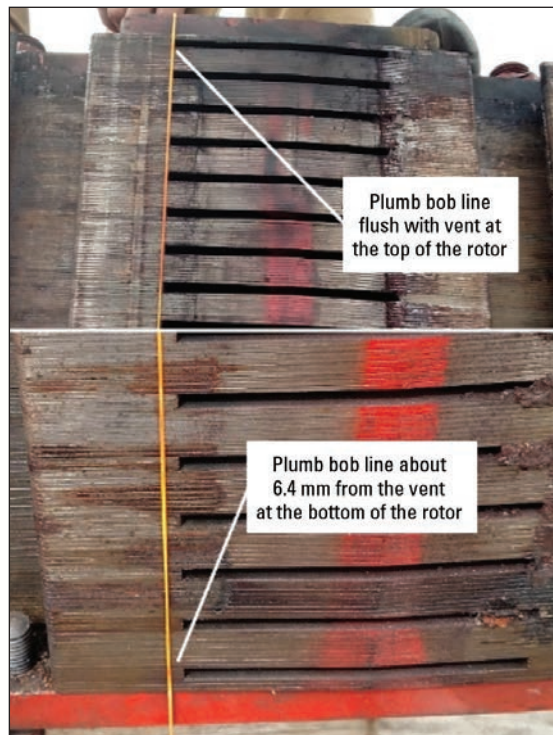
At a multi-unit refurbishment project, what started as finding crushed rim torque keys on one unit during the pre-project planning inspections led to determining that the original rotor rim design had insufficient original shrink and compression. All the rims were found to be 'skewed' to some extent where rim laminations had slipped relative to each other causing rim shape deformations from top to bottom while losing its shrink, which in turn had twisted and deformed the spider arms and imposed additional stress on the welding joints. The stresses and forces induced from this situation manifested themselves among different components. It was first seen as those crushed torque keys on one unit. During unstacking, another unit showed that the rim laminations themselves had twisted and buckled.

(b) Example of a skewed rotor rim.

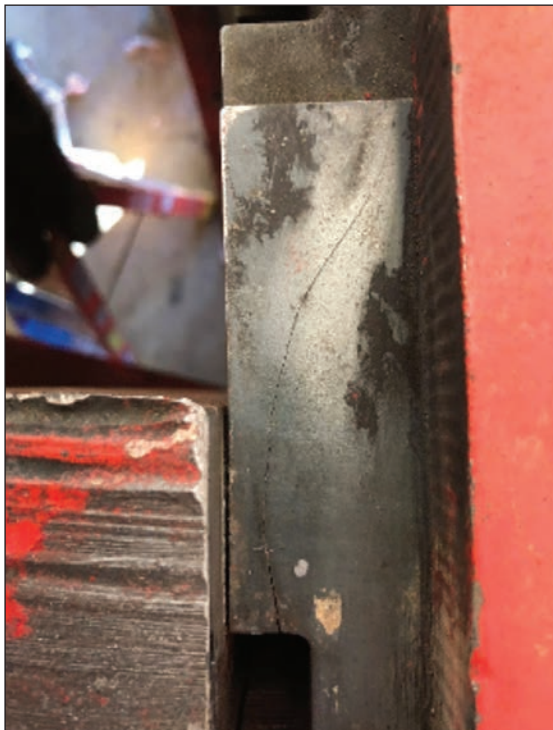
(c) Looking down on a cracked rotor rim lamination next to the shrink key slot.

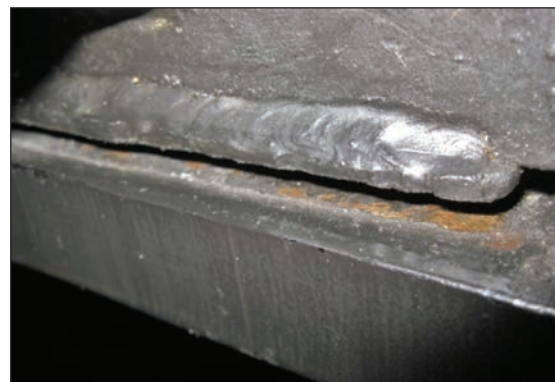
On another project, uneven gaps between the rim-mounted brake ring segments and spider arms were found during the initial generator inspection. Further investigations revealed that some of the spider arm support ledges had actually cracked or broken off completely, leaving the rim to sag under its own weight. The damage was so severe that an immediate 'do not operate' order was given with only one unit allowed to return to service under restricted operations and regular inspection. Only after replacing the damaged support ledges with an improved design, and prolonged forced outages, were the other two units allowed to return to service.

(d) Gap between spider arm and brake ring due to rim sagging.

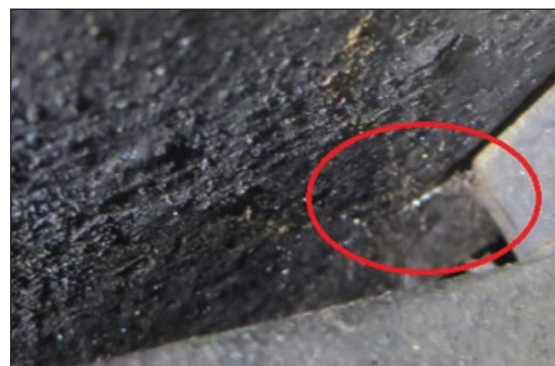
The additional tension on the twisted spider arms had also caused systematic cracking at stress-concentrated welds between the arms and the support ledge. On further inspection it was found that the marginal welding quality contributed to the cracking. The skew was found to be tolerable on two other units. On those units, the rim bolts were retorqued to prevent further lamination slippage and then the rim was reshunk to reestablish the original design intent. Understanding the original design intent as well as thorough investigations into the interactions of stresses and forces between components were critical to developing individual refurbishment plans for each unit.

(e) Hair-line crack on a spider arm support ledge.

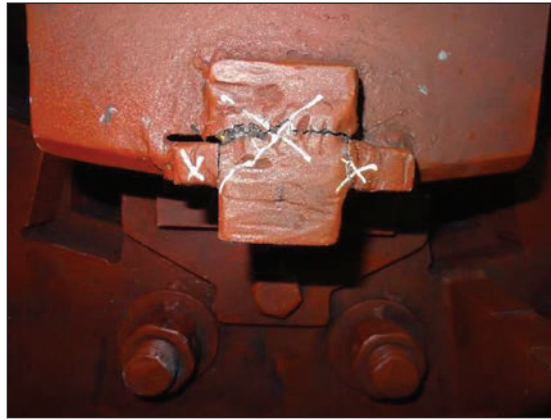
(f) Tangential crack on rotor radial key.

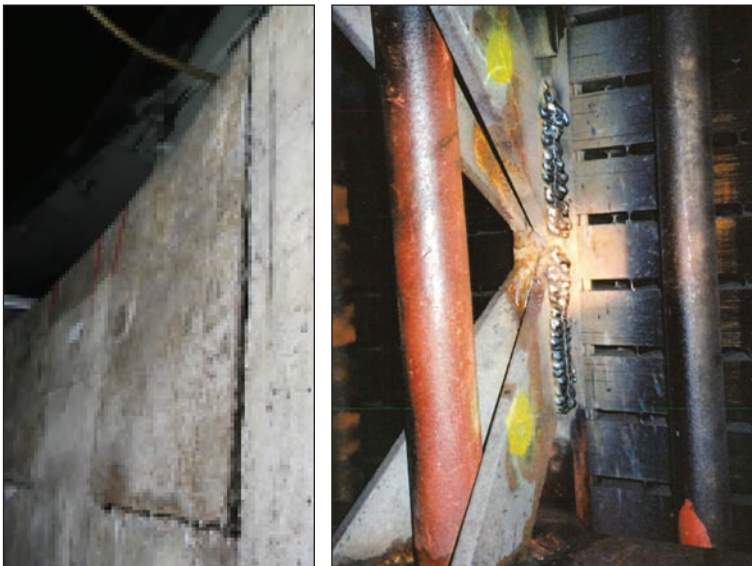
The stator is very important in the successful operation of a generator. The potential for stator movement must be understood and included in the design. Stantec has come across numerous projects where the stator core connections to the frame (which are typically welded) have broken loose from the frame, and many instances where a split joint in the stator, placed there for transportation limits, has mechanically opened up. Both events have led to premature and catastrophic failures of the stator windings as a result of additional mechanical and consequently electrical stress on the winding insulation systems. In most of these instances, but not all, the problems can be traced back to the design of the sole plates and their connection to stator frame that are not suitable to allow proper thermal expansion. Typical thermal expansion of a stator on a large generator is around 3 to 4 mm on a machine with an 80°C rise and if the stator cannot expand, that stress will eventually break the foundation, structural parts or cause excessive core buckling. In one instance, the concrete around the sole plate broke. It was found that the entire sole plate block was moving freely as one piece in and out towards the shaft.

(g) Sole plate grout block protruding from concrete wall towards the shaft.

(h) Above right: Stiffeners were welded to the back of the keybar to address cracks in the keybar, however the stiffener welds cracked from top to bottom.

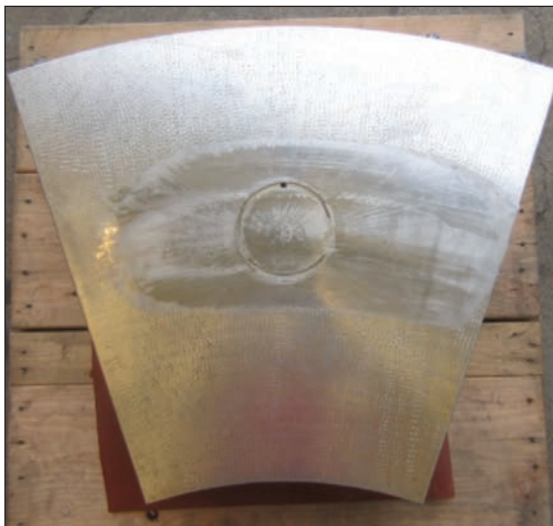
The thrust and guide shoes form the remainder of the generator bearings. The quality of shoe rebabbiting is important to the health of the machine. With modern high-pressure lift systems, the old method of scraping is not necessary anymore, and continuing to use scraping could lead to failure. On one project with a lift system, the first sets of thrust shoes were rebabbiting and still scraped per the manufacturer’s typical process. After twice reinstalling and loading the unit up to 70 per cent during commissioning, the bearing oil film collapsed, and two sets of shoes were wiped. It was later determined that the scraping was too deep, leading to a thick, and thus less stiff, oil film that was unable to support the bearing load. Additionally, the scraped pockets were interconnected, leading to oil being squeezed off the shoes and further collapsing the bearing’s support. By now, the importance of inspecting the right parameters during quality control inspections should be clear. Understanding the practice of scraping and its design function was certainly important in this case.

(i) Wiped thrust bearing shoe.
