Supplemental Grouting at NEELUM JHELUM DAM

BY JOSEPH R. KOVACICH, PE
STANTEC, GEOPRACTICE LEAD, POWER & DAMS (CHICAGO, IL)
&
MASROUR H. KIZILBASH, PG
STANTEC, VICE PRESIDENT AND CHIEF GROUTING ENGINEER (CHICAGO, IL)

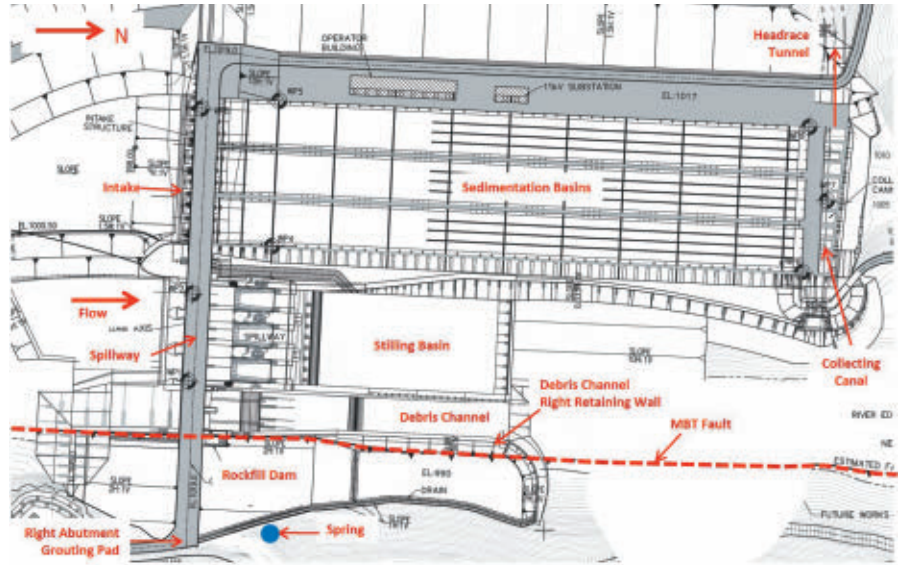
Figure 2 (right): Lot CI Headworks, Spring, and Right Abutment Grouting Area.

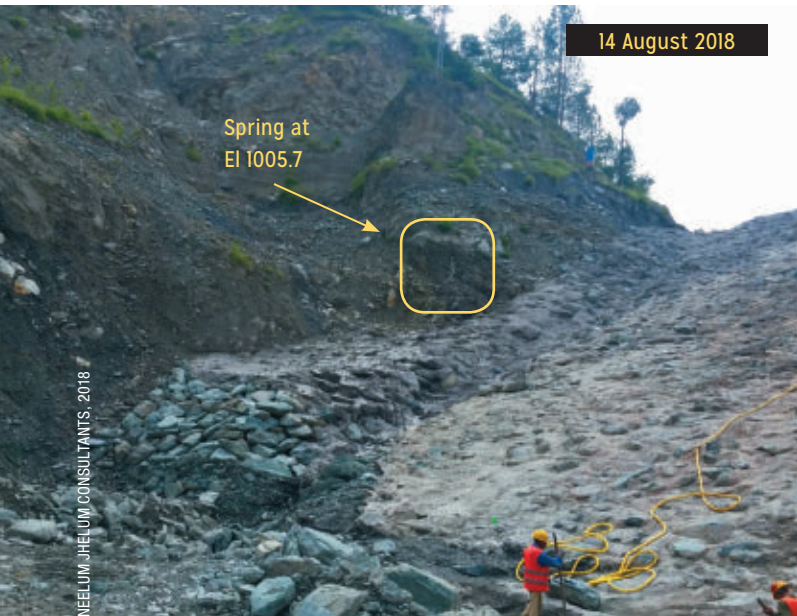
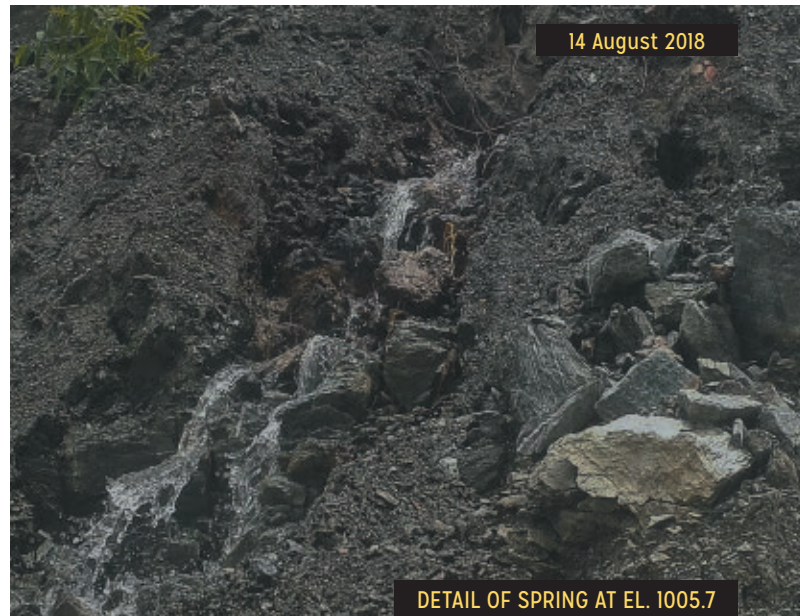
On August 15, when the reservoir reached El. 1011 m, a spring was observed on the downstream right bank. Located approximately 45 meters downstream of the dam axis near El. 1005.7 m (Figure 2), seepage was visually estimated to be between 300 and 400 L/min (Figure 3), and the seepage was clear. Flow from wall drains was also greater and flowed from six drains (Figure 4).

Figure 3: Spring on Downstream Right Bank (left) and Close-up (right).

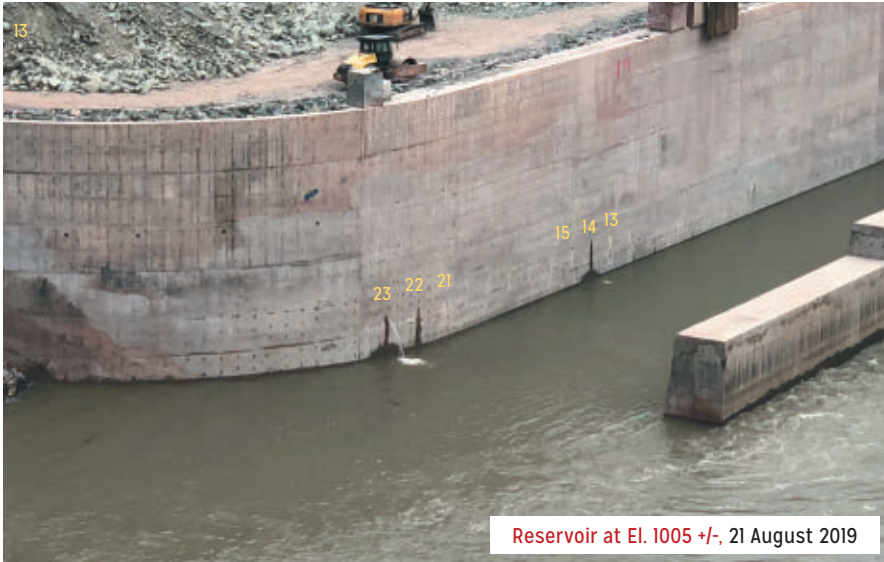
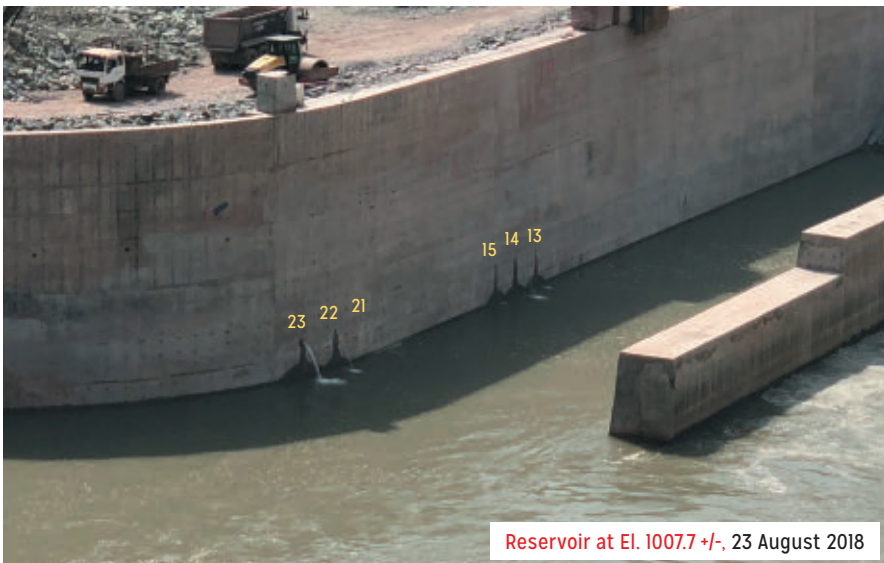
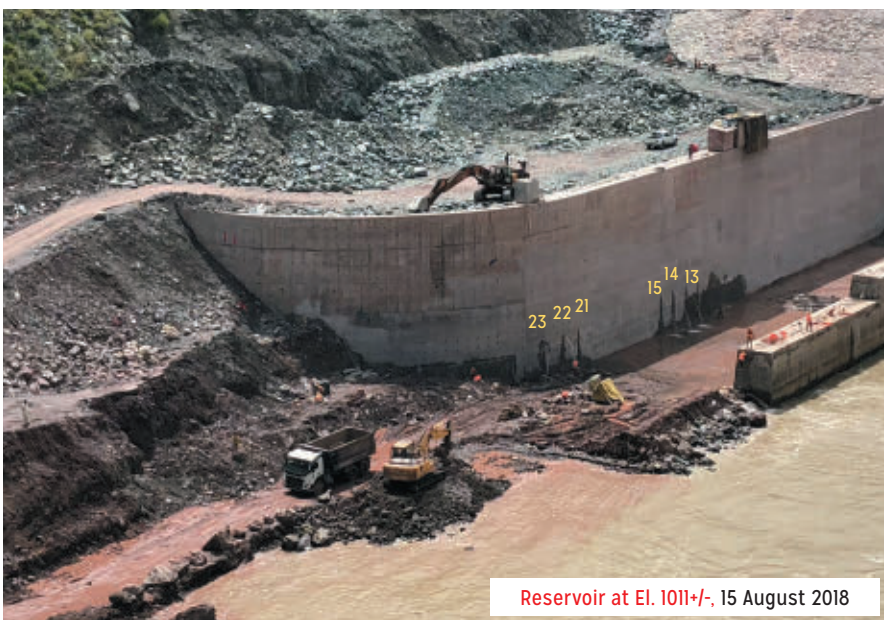
In late July 2018, 100 mm diameter drains were being drilled in the Debris Channel retaining wall at El. 974 m when significant seepage was reported from some drains. On August 4, 2018, with the reservoir at El. 1006 m, the combined seepage from the drains was estimated to be 2,100 L/min with most of the flow discharging from three of 23 drains: D-14, D-22, and D-23. Though high flows were anticipated initially as the rockfill behind the wall drained, the flows were persistent.

The following week, the reservoir level fluctuated between El. 1005 m and El. 1008 m. Visual observations of the wall drains confirmed a strong correlation between the reservoir level and seepage (Figure 4), which indicated seepage likely flowed through the right abutment at locations covered by the dam's downstream rockfill shell.

Figure 4: Seepage from Debris Channel Wall Drains.

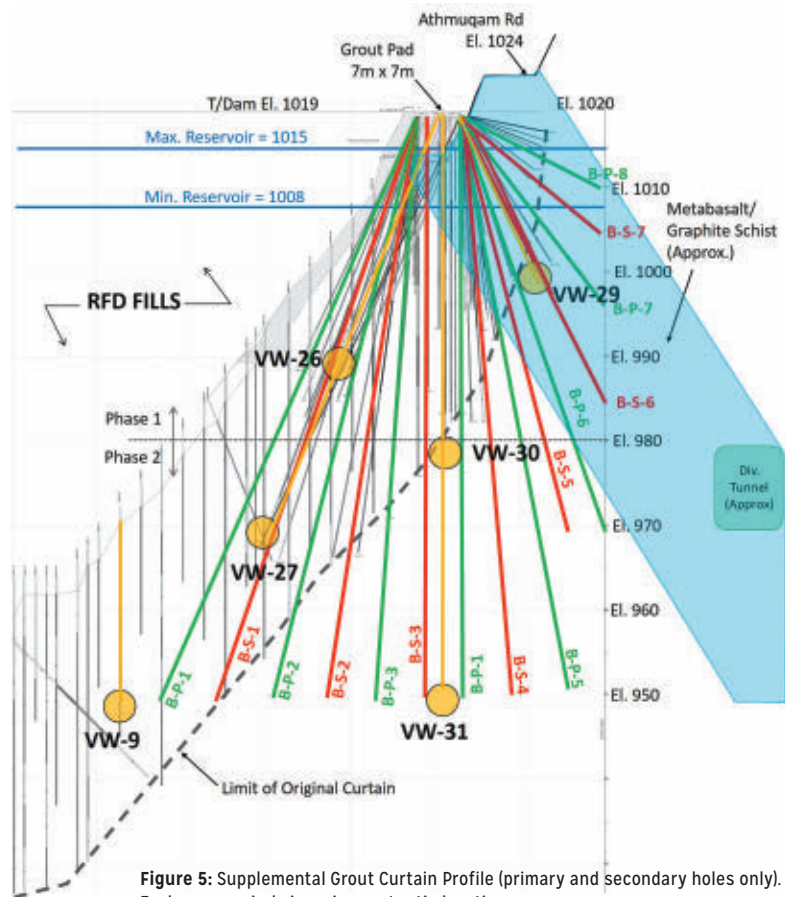
Four piezometers were installed in the right abutment as part of the original construction (Figure 5). Vibrating wire piezometer VW-9 is in-line with the grout curtain and set at El. 950 m. VW-10 (not shown) is approximately 30 meters downstream of VW-9 and also set in rock at El. 950 m. VW-26 and VW-27 are approximately 2 meters downstream of the grout curtain and set in the right abutment at El. 990 m and El. 968 m, respectively. To improve coverage during supplemental grouting VW-29, VW-30, and VW-31 were installed downstream of the grout curtains as shown on Figure 5. Data were reviewed daily.

Figure 5: Supplemental Grout Curtain Profile (primary and secondary holes only). Each orange circle is a piezometer tip location.

The supplemental grout hole layout consisted of eight primary and seven secondary holes located along a B-line centered 2.5 meters upstream of the original curtain drilled from a grout pad at El. 1019. In Phase I the holes would

extend to El. 980 m, and if Phase 2 was needed, the pattern would extend as deep as El. 950 m.

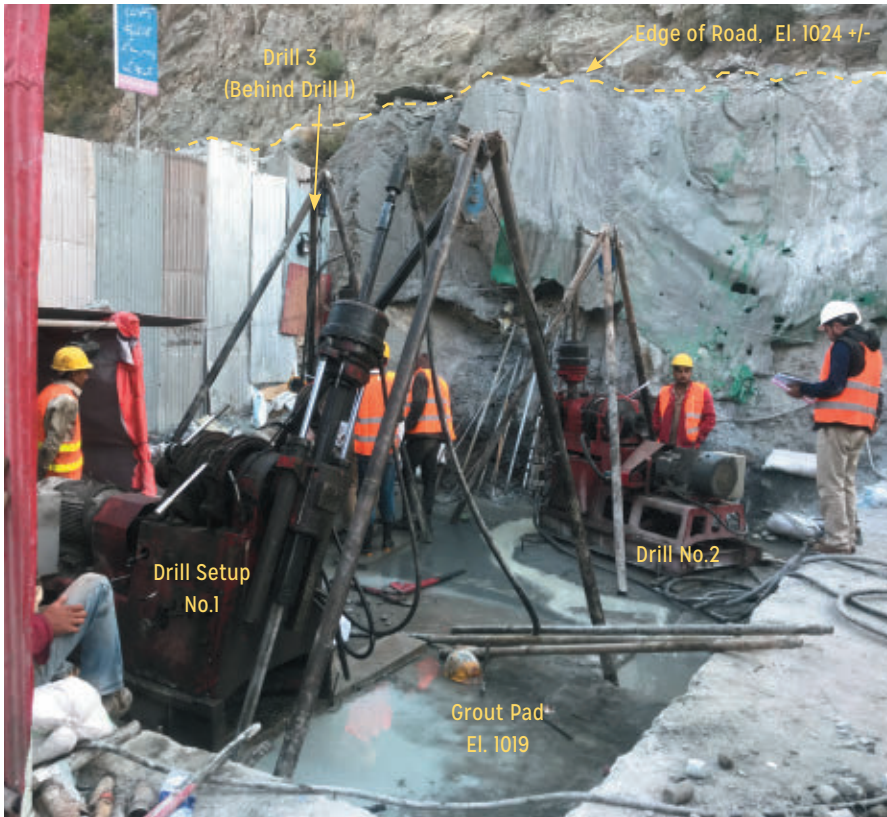
Though the work was being expedited, several constraints and challenges had to be overcome. The narrow Athmuqam road, which is critical to Pakistani Kashmir security and is just a few meters above the dam's right abutment could not be disrupted during original construction to facilitate a gallery at that level. Nor was the road wide enough to permit supplemental drilling from it during and keep the road open. The concrete grout pad at El. 1019, which measured approximately 7 m x 7 m, was the only viable space; but the pad only accommodated three drills (Figure 6). The restrictions also meant hole angles were limited.

Figure 6: Grout pad at El. 1019 offered approx. 7m x 7m work area.

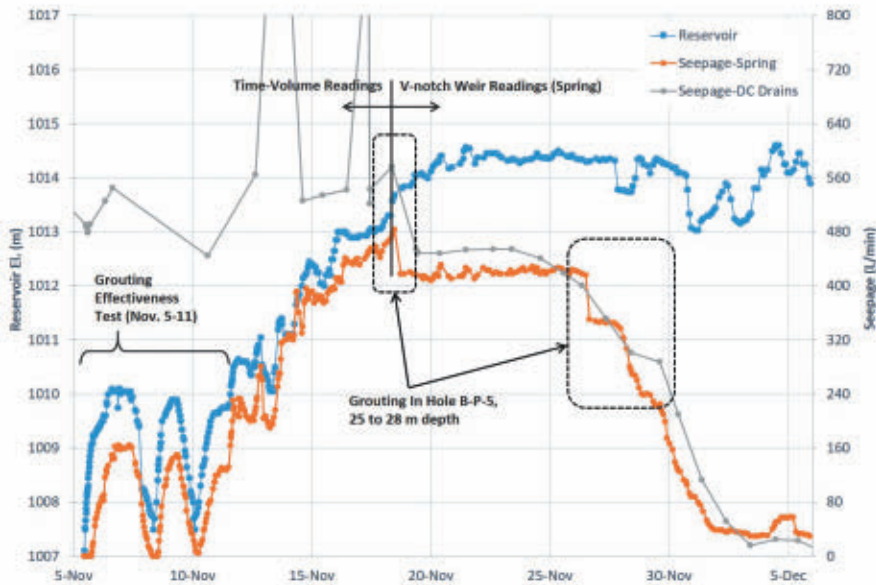
On November 5, the reservoir was raised from El. 1007 m to El. 1010 m and held for 24 hours. When the reservoir reached approximately El. 1009 m, seepage emerged from the spring, and with the held at El. 1010 m, the seepage from the spring was stable at 160 L/min, and seepage from the Debris Channel drains was approximately 500 L/min, both substantial reductions (Figure 7). The piezometers also showed behavior consistent with a tightened curtain.

Figure 7: Reservoir and Seepage Data from 5 November to 6 December 2018.

Seepage from the spring and the wall drains suddenly reduced (Figure 7), indicating a major seepage pathway had been grouted. Additional grouting reinforced this area over the next several days, and by December 2 the spring measured only 30 to 40 L/min. Drain hole seepage had been reduced to 50 L/min by December 2, and all drains were dry by December 7 and remain so today.

By November 17, the reservoir neared El. 1014 m, and seepage from the spring had steadily increased to approximately 480 L/min. During that night shift, 7.6 tons of cement were injected into hole B-P-5 at depth of 25 to 28 meters without reaching refusal. The next day, 3.6 tons of cement were injected in the same stage, again without reaching refusal, so the Contractor elected to move to a new hole. The seepage measurement that day indicated the spring seepage reduced to 420 L/min, a 12 percent reduction, while seepage from the wall drains reduced from approximately 560 L/min to 450 L/min, a 20 percent reduction. The reductions hinted that the B-P-5 stage had intercepted a prominent seepage path. Seepage remained steady until November 26 when the reservoir neared El. 1014.5 m, and the Contractor returned to B-P-5 to resume grouting the 25 to 28 meter

deep stage. After two days of near continuous injection of 20.7 tons of cement, the stage reached refusal.
