Supplemental Grouting at NEELUM JHELUM DAM

BY JOSEPH R. KOVACICH, PE
STANTEC, GEOPRACTICE LEAD, POWER & DAMS (CHICAGO, IL)
&
MASROUR H. KIZILBASH, PG
STANTEC, VICE PRESIDENT AND CHIEF GROUTING ENGINEER (CHICAGO, IL)

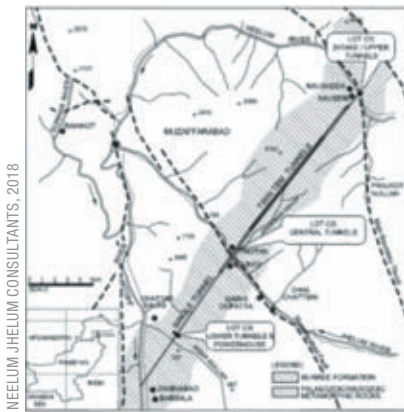
Figure 1 (above): Neelum Jhelum Hydroelectric Project Layout.

Divided into three construction lots (Figure 1), Lot C2 includes the central headrace tunnel and Lot C3 includes the surge shaft, penstocks, powerhouse complex, and tailrace tunnel. Lot C1, which is the focus here, includes the headworks and the initial section of the headrace tunnel. The headworks (Figure 2) includes a 58-m-high concrete gravity dam with crest at El. 1019 m, a gated spillway, and a gated debris channel. The dam diverts water through the intake, sedimentation basin, and collecting canal and then into the headrace tunnel. Considered active, the Main Boundary Thrust fault (MBT) traces the right riverbank, which necessitated a 54-m-high zoned core rockfill dam (RFD) be constructed over the highly fractured and disturbed rock to accommodate potential fault movements and reduce effects that fault rupture could have on the concrete structures (Dickson et al. 2013; Kovacich et al. 2020).
